# Survey of the Wreck of the *Thor*

Cardiff BSAC 0590

BSAC Expedition BEGS-08-05

October 2008

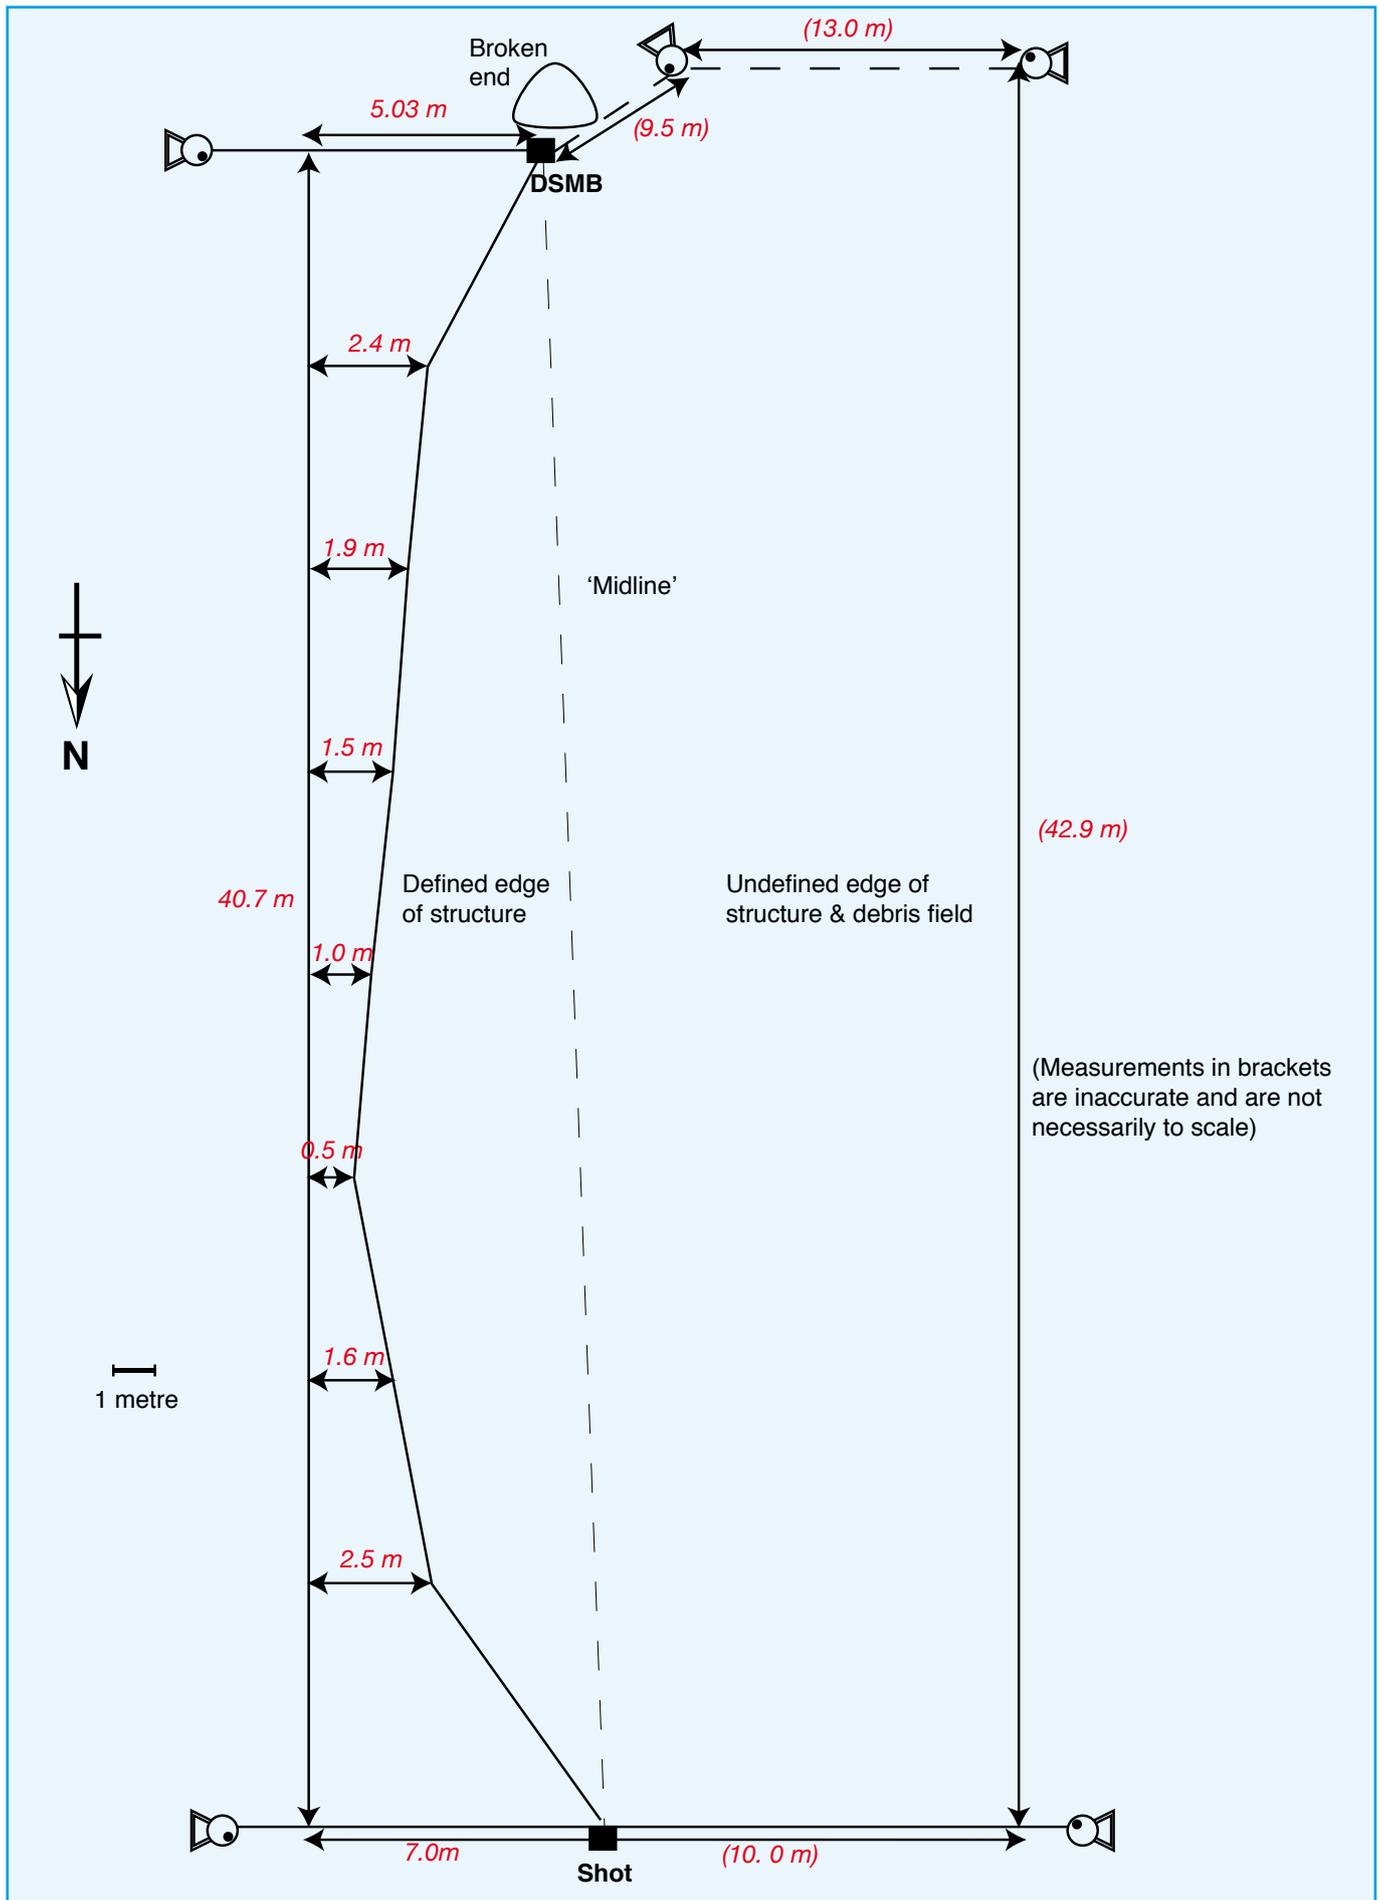
Figure 4.3: Schematic of wreck, drawn to scale from survey results

- The overall length of the wreck has been determined  
*Approximately 43 m from bow to stern*
- The maximum width of the wreckage area has been determined  
*No more than 17 m across the widest section*
- A general area has been defined within which all of the debris can be found
- The height of the wreck off the seabed was determined relative to the defined edge of the hull on the seabed (Figure 4.4)  
*Up to 3 m off the seabed at the stern*
