# Survey of the Wreck of the *Thor*

Cardiff BSAC 0590

BSAC Expedition BEGS-08-05

October 2008

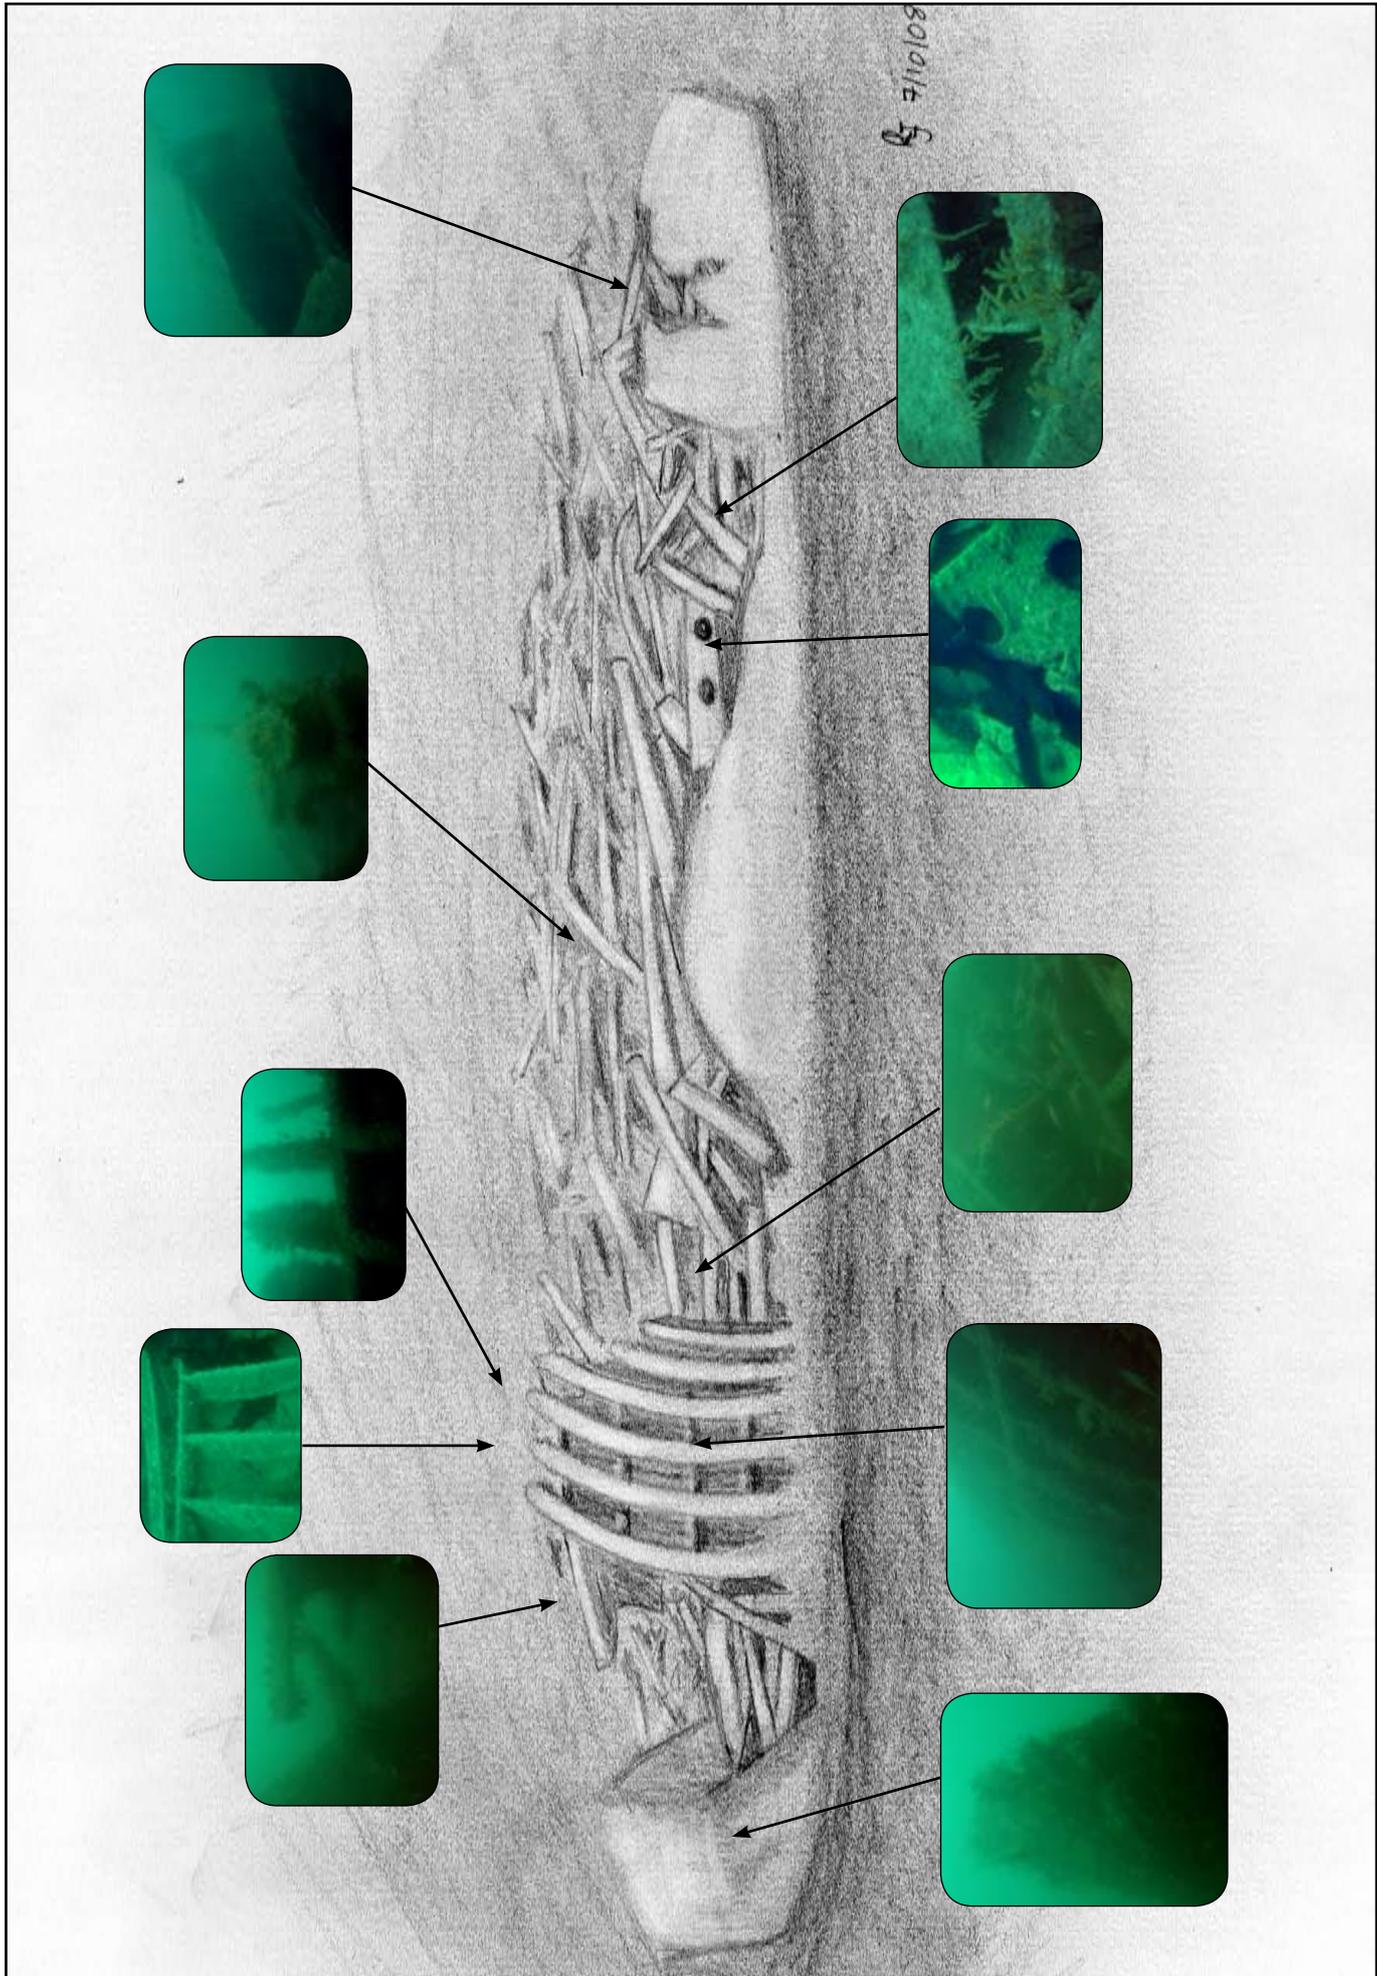
Figure 4.5 (below): Illustration of the wreck with photographs related to various points around the site. Illustration is drawn to the same scale as the schematics in Figures 4.3 & 4.4.

- An illustration of the general wreck site was made (Figure 4.5)
- A combination of the illustration and digital imagery is shown in Figure 4.5 to give a more realistic view of the appearance of the wreck site
